STATE OF CALIFORNIA
TRANSPORTATION AGENCY
DEPARTMENT OF PUBLIC WORKS
DIVISION OF HIGHWAYS

A SURVEY OF EARTH-BORNE VIBRATIONS
AT PARKSIDE MEDICAL - DENTAL BUILDING

OCTOBER 1967

Project W. O. 36418

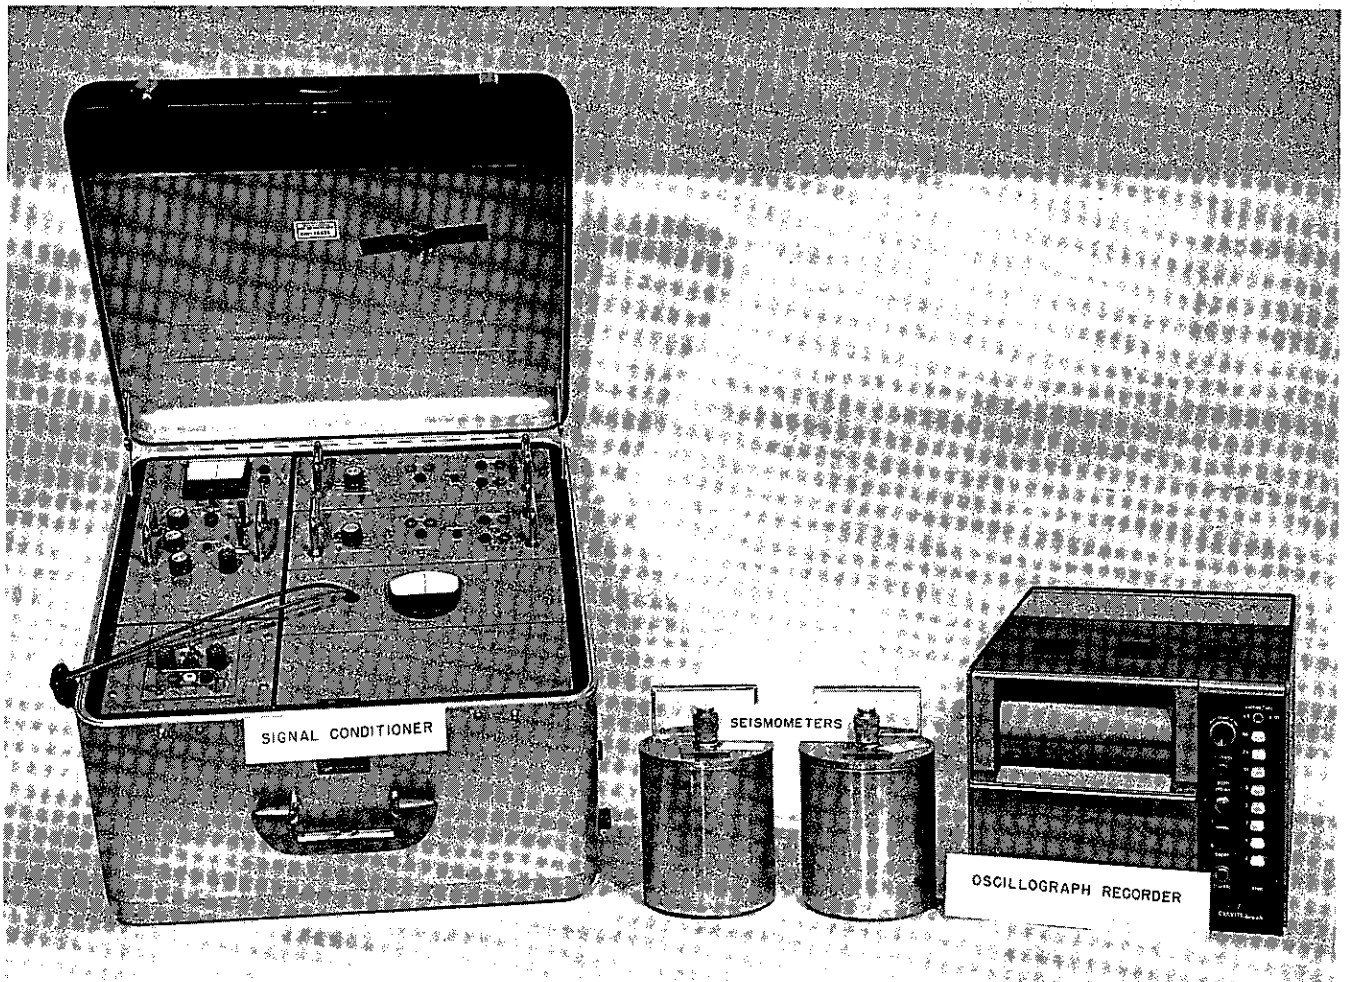
FIGURE 3

Vibration measurements during a test run were recorded simultaneously with two seismometers and their associated equipment shown in Figure 3.
